**AFPTEF REPORT NO. 10-R-03  
AFPTEF PROJECT NO. 10-P-105**

**QUALIFICATION TESTING OF THE SMARTVAULT HOUSEHOLD GOODS  
SHIPPING CONTAINER**

**403 SCMS/GUEB  
AIR FORCE PACKAGING TECHNOLOGY & ENGINEERING FACILITY  
WRIGHT PATTERSON AFB, OH 45433-5540  
6 January 2011**

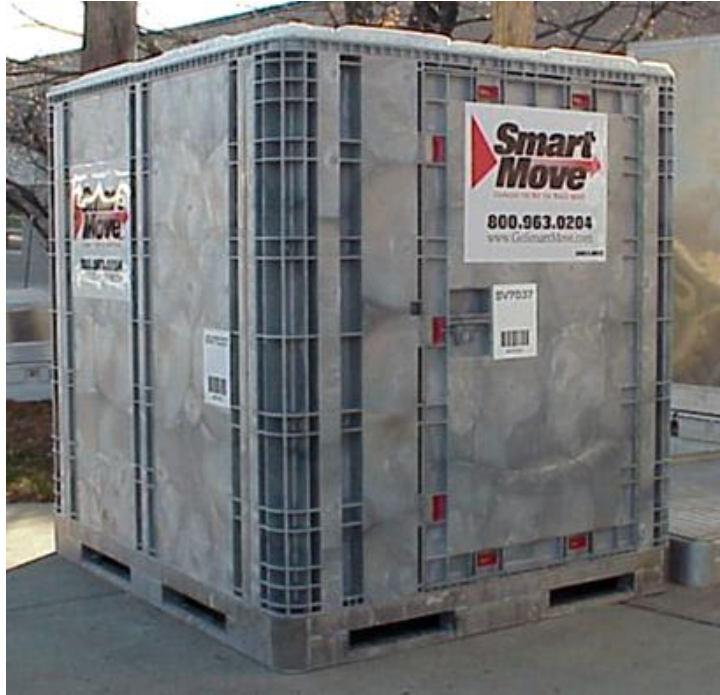
**Figure 1.** SmartVault container – forward view.

**CONTAINER DESIGN** – The SmartVault container (Appendix 2, Figures 1 - 7) consists of an aluminum base with 4-way forklift entry and molded high-density polyethylene (HDPE) ribbed walls and (translucent) lid which are held together with stainless steel bolts. Container walls fit into a channel on the upper edge of the pallet base and are held in place with stainless steel bolts that go through the channel and wall. The hinged door is secured using recessed plastic latches which slide through the door edge and insert into blind openings in the doorframe (Appendix 2, Figure 8); these are held in place by handle

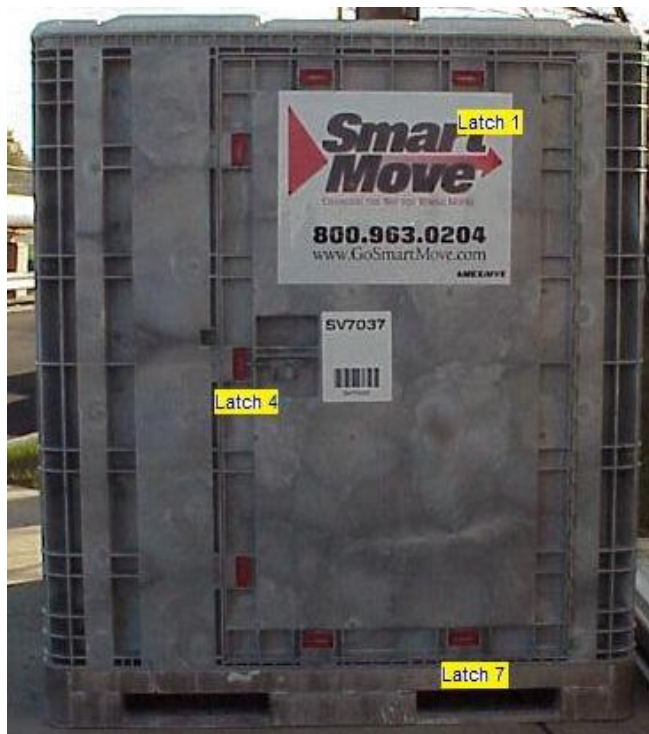
**Figure 2.** SmartVault container – forward view with counterclockwise door latch numbering system.

In addition, the seven latches were numbered, in counter-clockwise order, starting with the upper hinge-side corner of the door as latch 1 (Appendix 2, Figure 2).

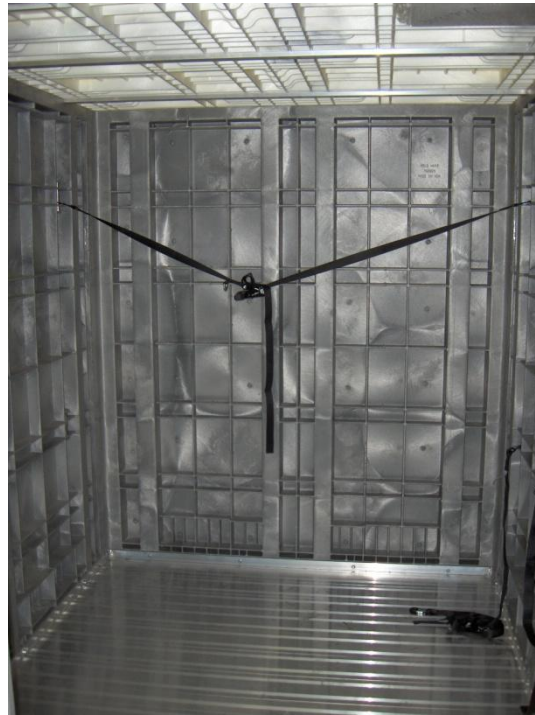
**Figure 3.** Container interior, showing molded walls and aluminum floor.

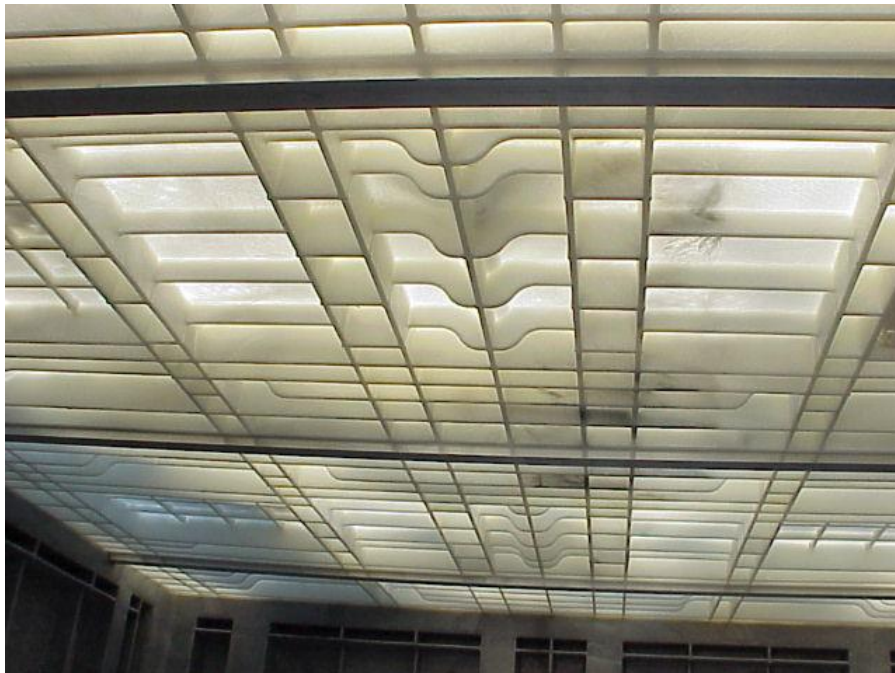
**Figure 4.** Interior view of container roof.

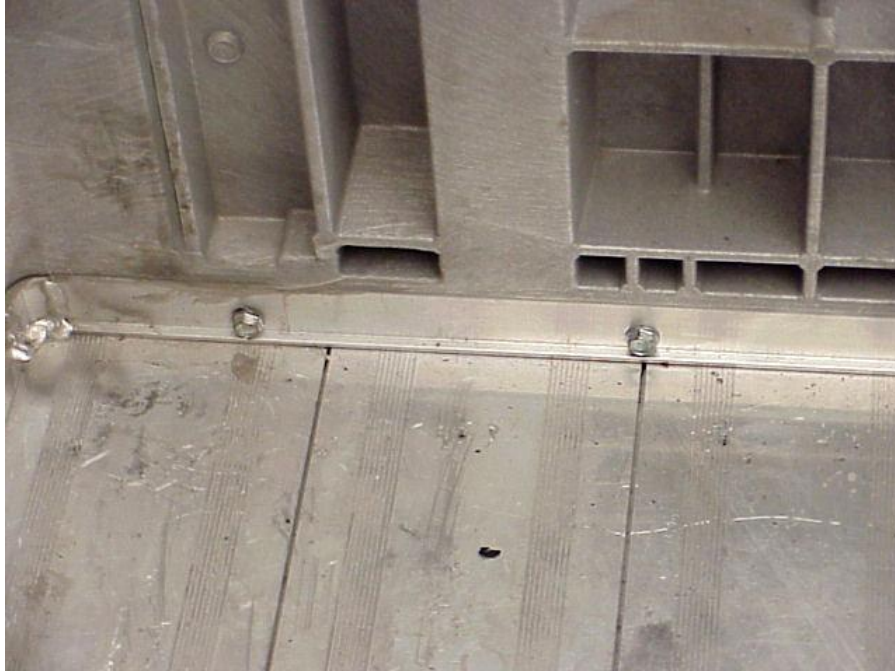
**Figure 5.** Wall/base interface, near a corner.

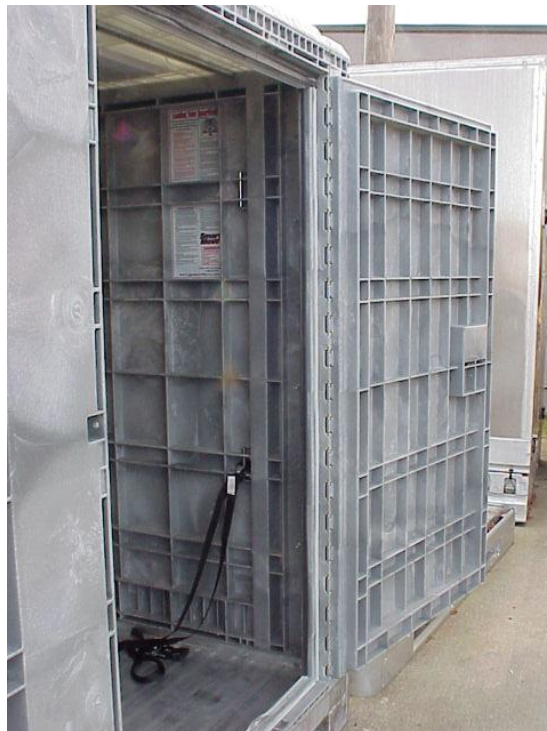
**Figure 6.** Doorway – hinge side.

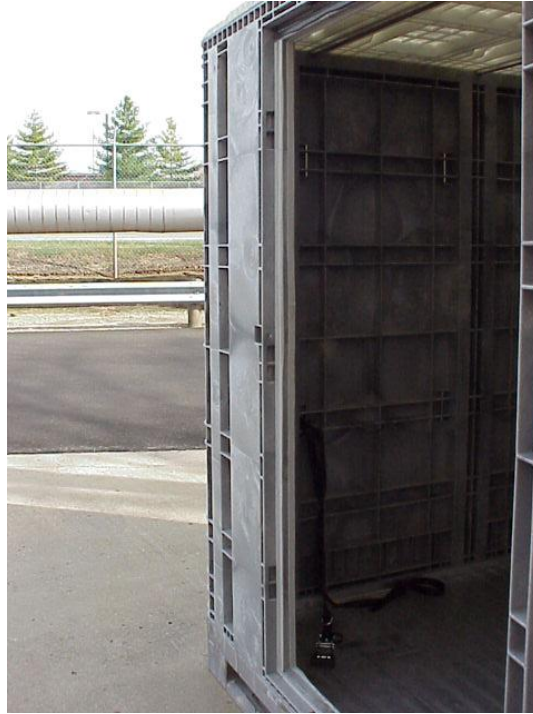
**Figure 7.** Doorway – latching side; note blind openings for latch insertion.

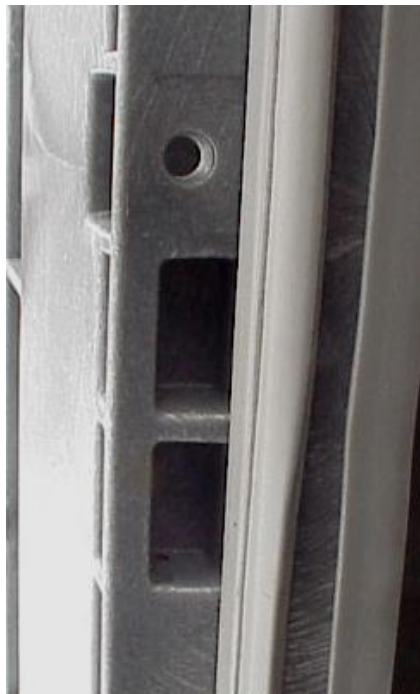
**Figure 8.** Blind openings for latch insertion; hole above for second lock.

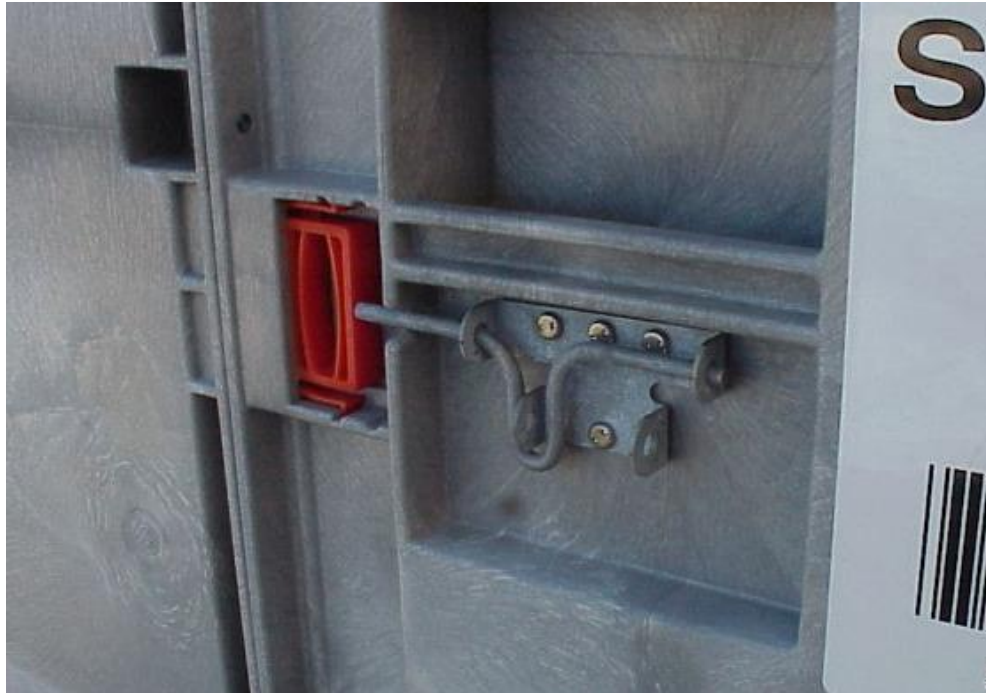
**Figure 9.** Latch 4 with lockable slide-bolt; note hole above latch for 2nd lock or seal.

tabs that snap into notches (Appendix 2, Figure 9) and are in the fully open position when in the second (farthest from door edge) groove. A lockable steel slide-bolt slips into place behind the center vertical latch (latch 4, Appendix 2, Figure 2 & 9) and can be padlocked to prevent casual pilferage. There is an additional hole in the door edge which corresponds to a hole in the doorframe, and can be used as a secondary locking location.

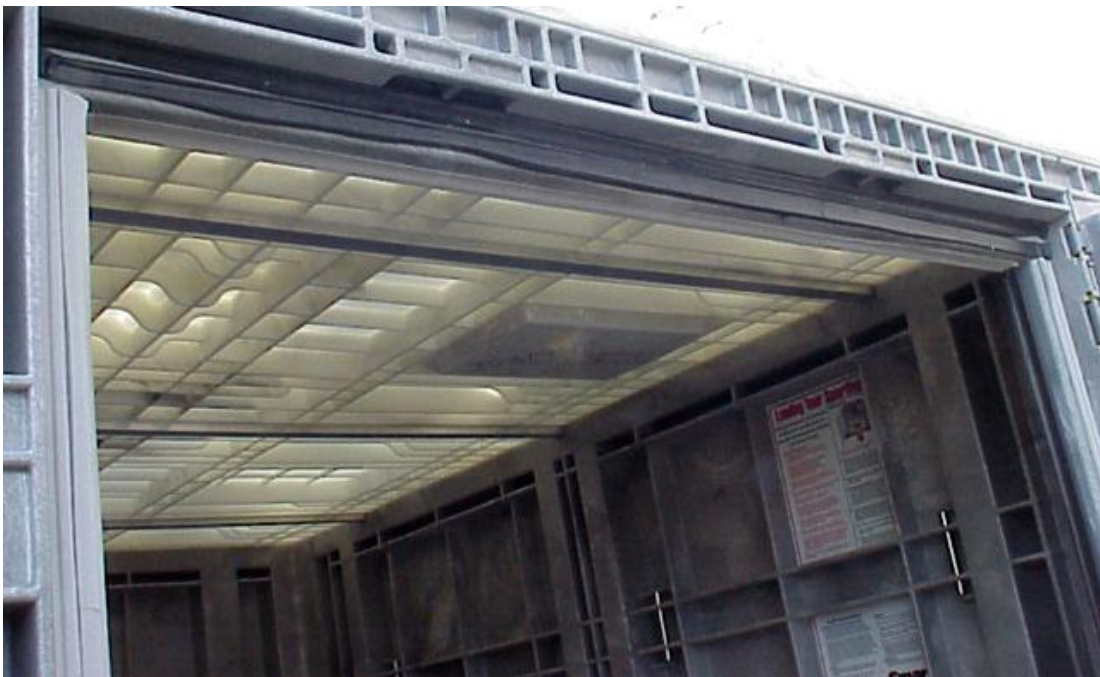
**Figure 10.** Upper doorway gaskets; note blind openings for latch insertion.

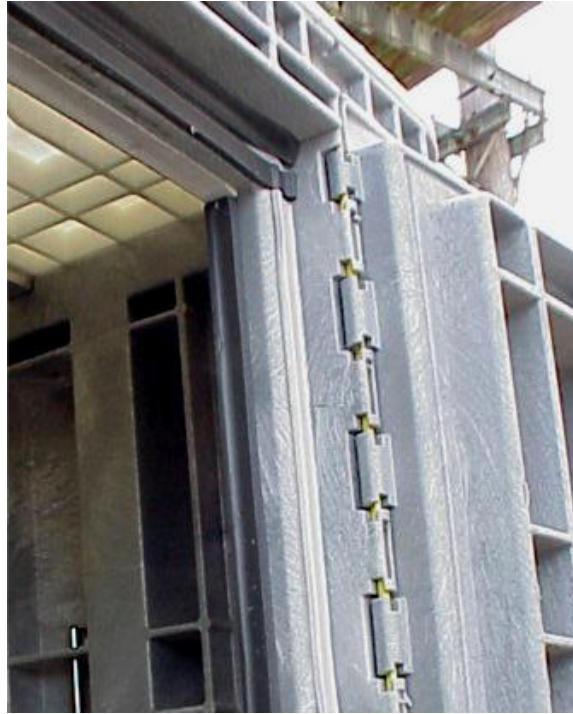
**Figure 11.** Hinge side door gaskets. Note overlap of upper doorway gaskets in corner; compression set & grooving of gaskets from door pressure is visible.

As noted above, the door latches are prone to partial and full releases during rough handling; combined with the set that the doorway gaskets can take, this could result in water entry around the door edges in actual use. We recommend that Smart Move consider modifying the door latch design to reinforce each latch’s closure and prevent inadvertent releases.

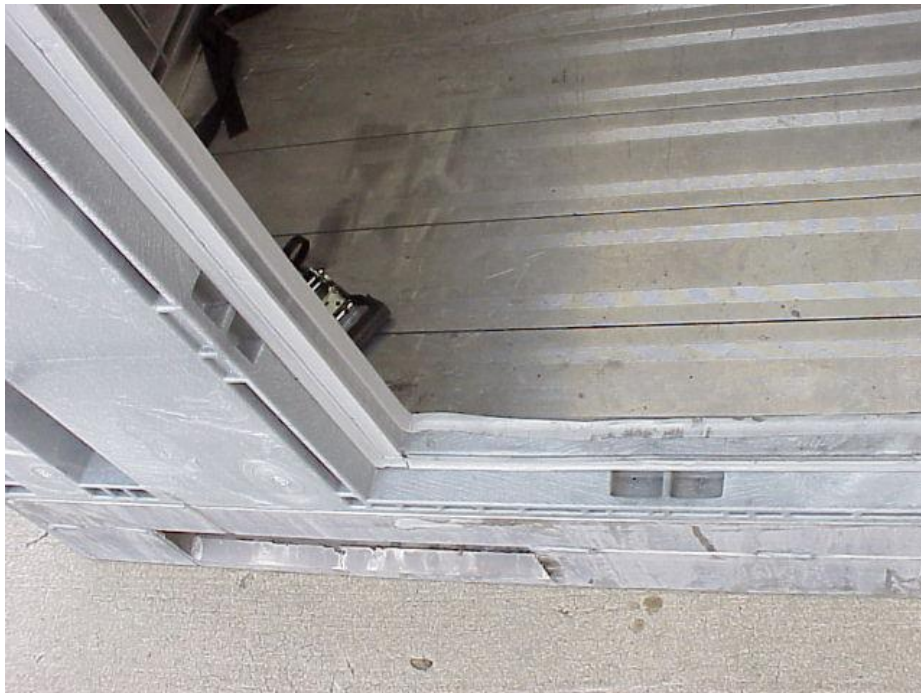
**Figure 12.** Latching side door gaskets, bottom corner.

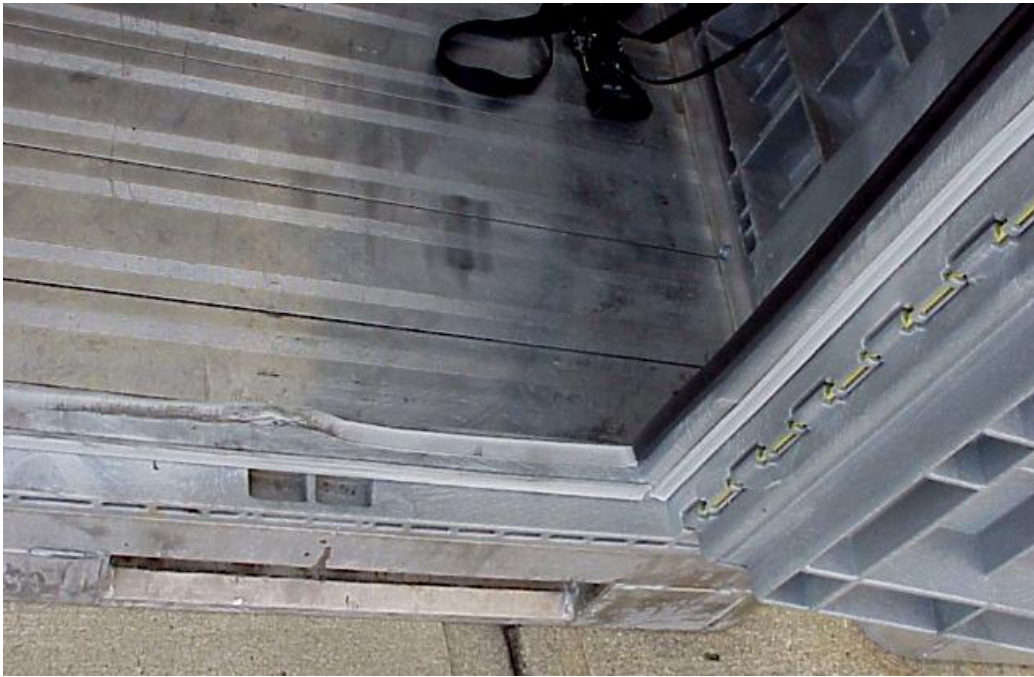
**Figure 13.** Doorsill gaskets, hinge corner. Note slight damage to horizontal gasket.

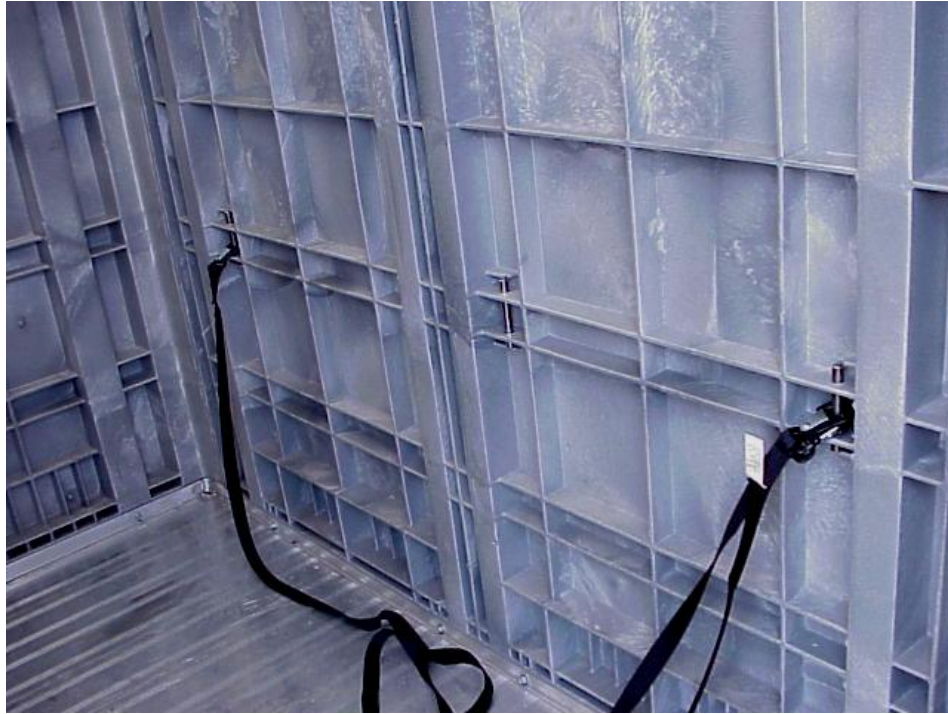
**Figure 14.** Internal tiedown point.

**Figure 15.** Internal tiedown points with Smart Move-provided cargo straps.

Stainless steel tubes (Appendix 2, Figures 14 & 15) set into the inner ribs of the side walls provide interior strapping tie-down locations. These tubes are too close to the wall and ribbing to allow use of the larger tie-down straps commonly used in the military (Appendix 2, Figures 36 & 37), and require use of smaller commercial-off-the-shelf tie-down straps (provided by Smart Move).

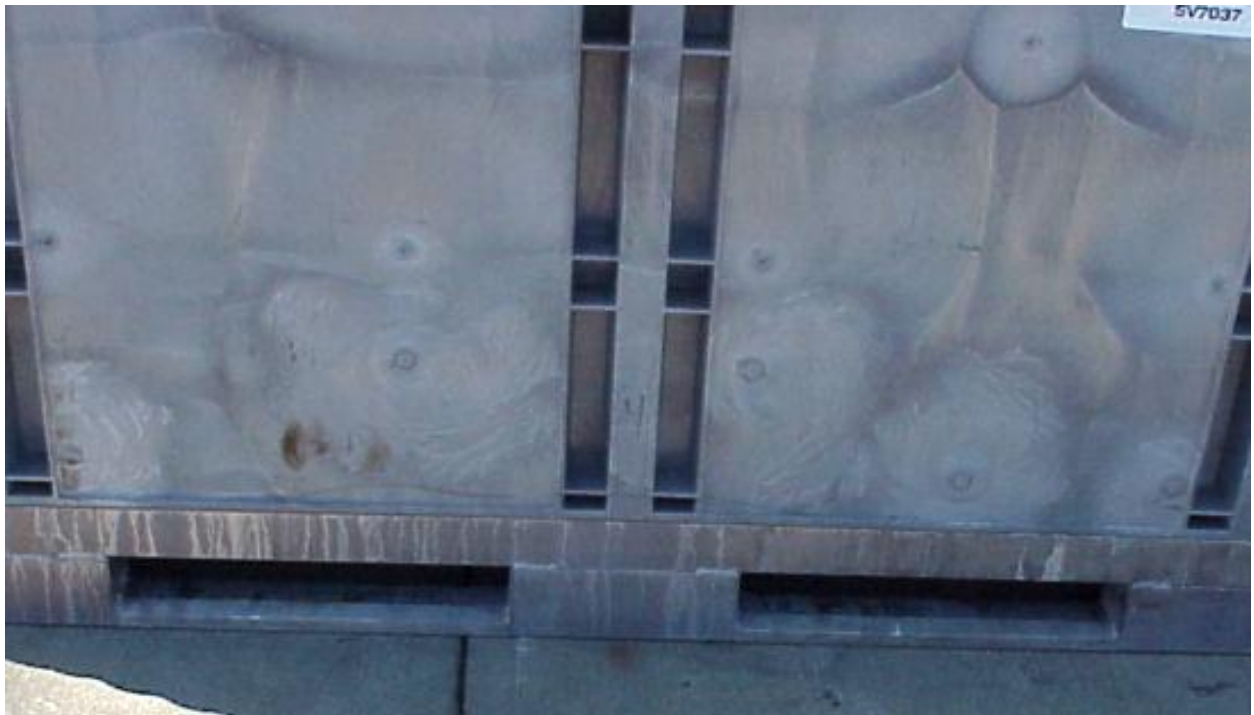
**Figure 16.** Forklift openings.

The container tare weight is 929 pounds. The gross weight as tested is 2995 lb, with a test load weight of 2066 lb. External dimensions are 90 in. (length) x 76 in. (width) x 88 in. (height); internal dimensions are 83 in. x 70 in. x 78 in. The door opening measures 40 in. (width) x 71.5 in. The aluminum pallet base is 8 inches high at the edges, and 7 inches high (inner floor surface). The forklift openings on the narrower ends are approximately 18 inches wide, 3 inches high and 18 inches apart. Forklift openings on the longer sides are approximately 21.75 inches wide, 3 inches high and 12 inches apart. The bottom edges of all forklift openings are beveled (Appendix 2, Figure 16).

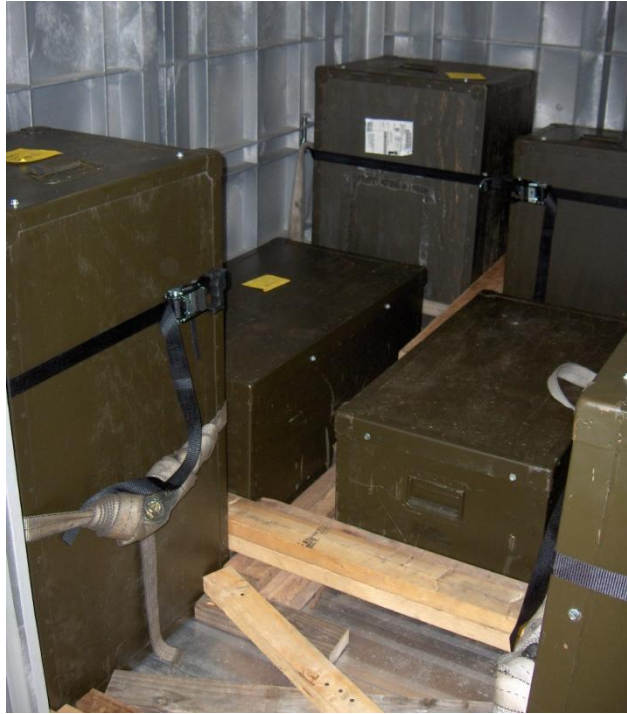
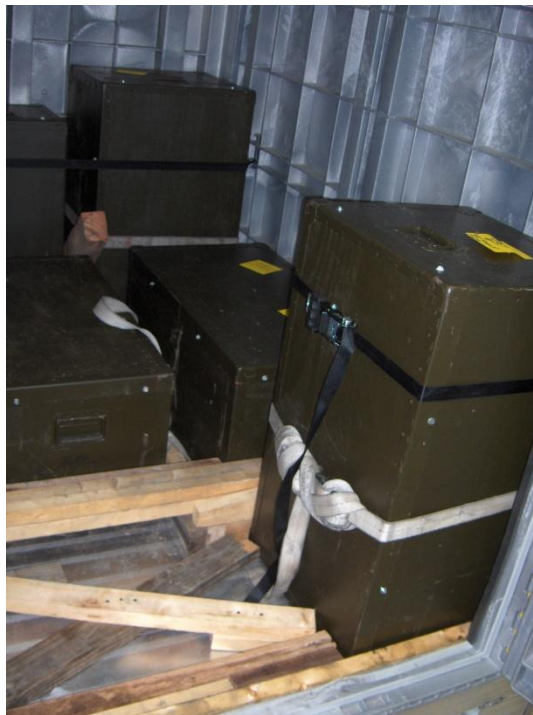
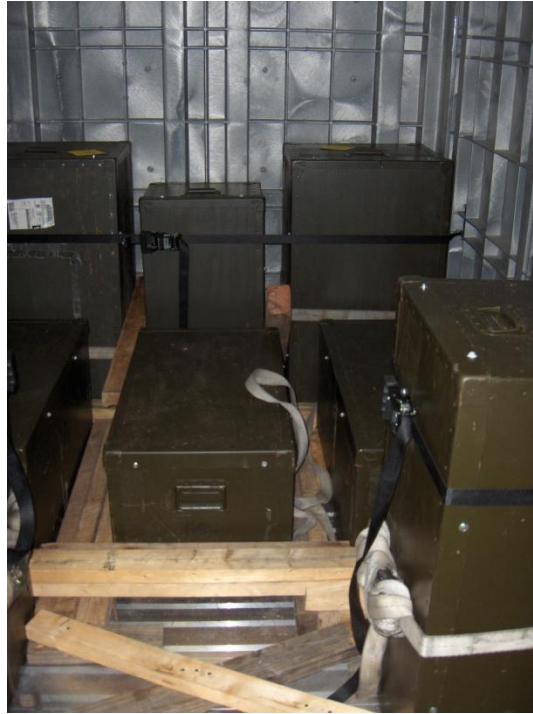
**Figure 17.** Test load arrangement, right side.

**Figure 18.** Test load arrangement, left side.

**Figure 19.** Test load arrangement, forward view.

**TEST LOAD** – The test load consisted primarily of iron weights and foam dunnage in closed wood boxes, with an average weight per box of 245 lb. This load was evenly distributed over the container floor with six boxes placed along the container walls and held in place with supplied cargo straps that were hooked to the internal tiedowns; a seventh box was placed in the center of the container floor and wedged in place with wood bracing (Appendix 2, Figures 17 -19). The center of gravity for this test load was approximately 1.5 feet off the floor of the container (this is lower than required by SDDC Pam. 55-12, but was approved by SDDC for this test). The test load weight was 2066 pounds, and the tested gross container weight was 2995 pounds.

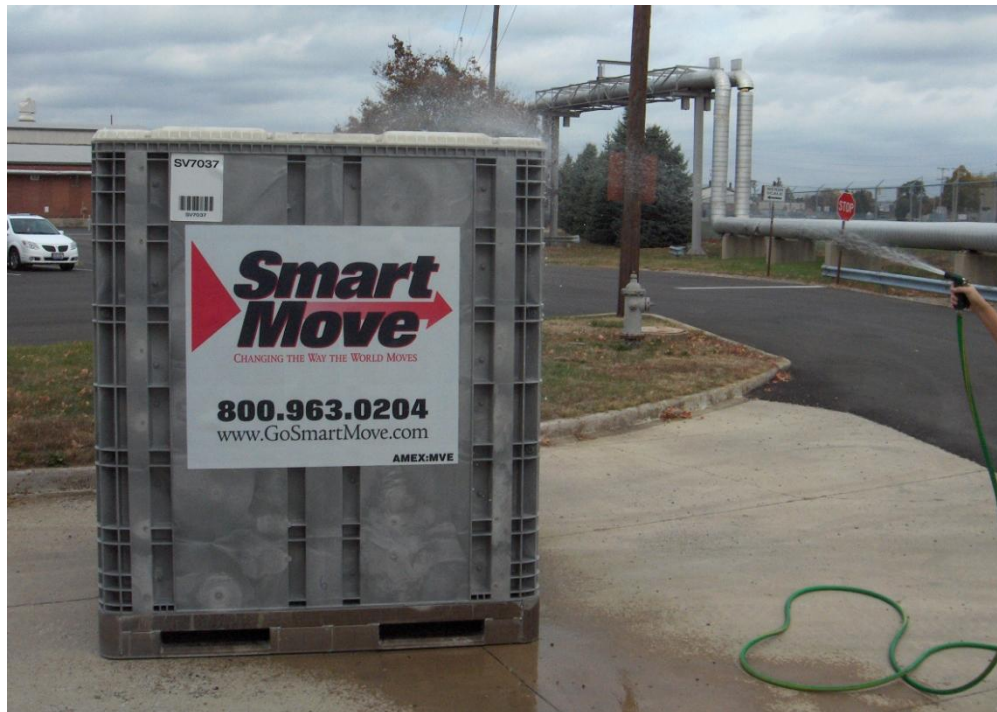
**Figure 20.** Rain test.

**Procedure** – The empty container was used for this test to permit complete inspection and observation of all interior surfaces and components. In accordance with MIL-STD-810G, 506.5, Procedure II (modified as described), the container was placed on a level surface and a large-droplet spray pattern of water (municipal water pressure 40 psig & ambient temperature) was applied to all container surfaces, using only one nozzle. Water was applied from a distance of 3 ft to 4 ft. The total test period was reduced to 45 minutes with the hose spray applied to each side for approximately 10 minutes, and focused primarily on seams and the edges of openings (Appendix 2, Figure 20). The interior was then examined for water incursions.

**Results** – At the end of the test period, no water was found in the container. There was no evidence of leakage past the door gaskets, nor any droplets at any of the wall/roof, wall/wall or wall/base interfaces.

Procedure – The container was emptied immediately prior to this test to permit complete inspection and observation of all interior surfaces and components during the test. Test Sequence 1 was immediately repeated and the interior was examined for water incursions during and after the test (Appendix 2, Figure 20).

Results – At the end of the test period, no water was found in the container. There was no evidence of leakage past the door gaskets, nor any droplets at any of the wall/roof, wall/wall or wall/base interfaces.

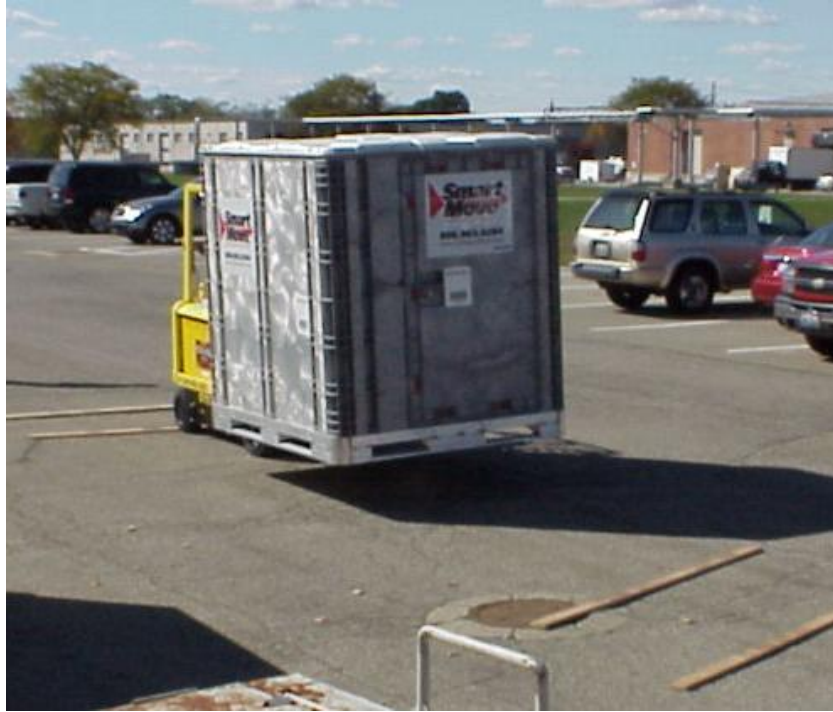
**Figure 21.** Forklift transport test, ambient.

**Procedure:** The container was picked up by the tine openings on the aft side and driven over the test course 1 round trip (forward and backward) (Appendix 2, Figure 21). The container was placed on the ground, picked up on an adjacent side, and again driven over the test course 1 round trip.

**Results:** There was no instability, weakening of, or damage to any component of the container. The container met test requirements.

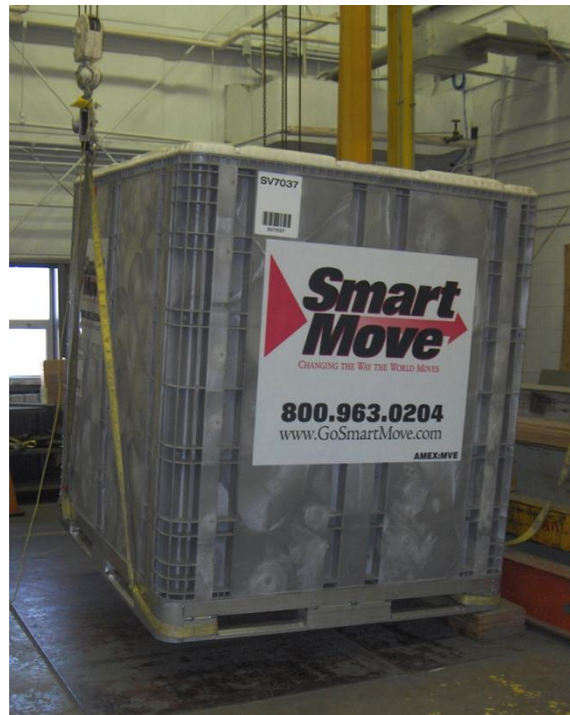
**Figure 22.** Rotational cornerwise drop, ambient.

**Procedure** – An Assurance Level II drop height of 9 inches was used to perform four corner and four edge drops of the container onto a smooth concrete surface (Appendix 2, Figure 22). The container was visually inspected for damage.

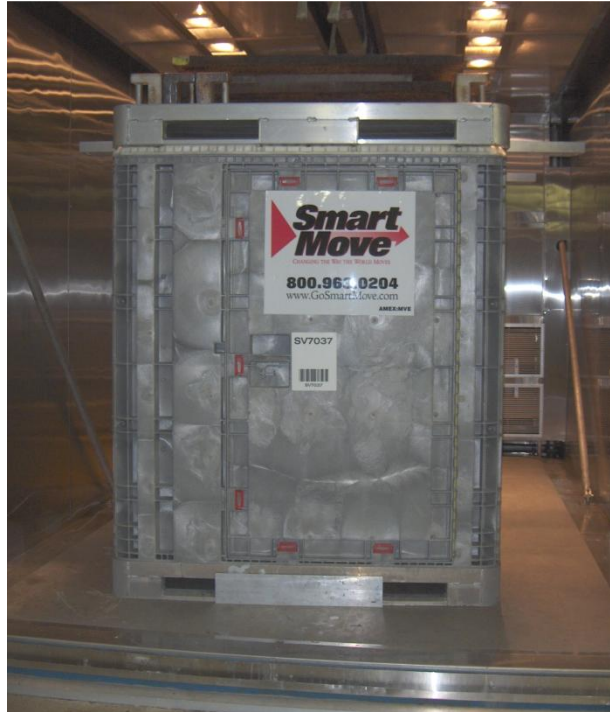
**Figure 23.** Stack test, +125°F & 95% RH.

**Procedure** – A 7377 lb stack test weight, consisting of one identical aluminum container pallet base with steel and iron weights, was placed on top of the container. The container, with the test load, was placed in an environmental

chamber for 24 hours at the above temperature and humidity (Appendix 2, Figure 23). At the end of the test period, the weight was removed from the container and the container was visually inspected.

Results – There was no damage or deformation of the container. The container met the test requirements.

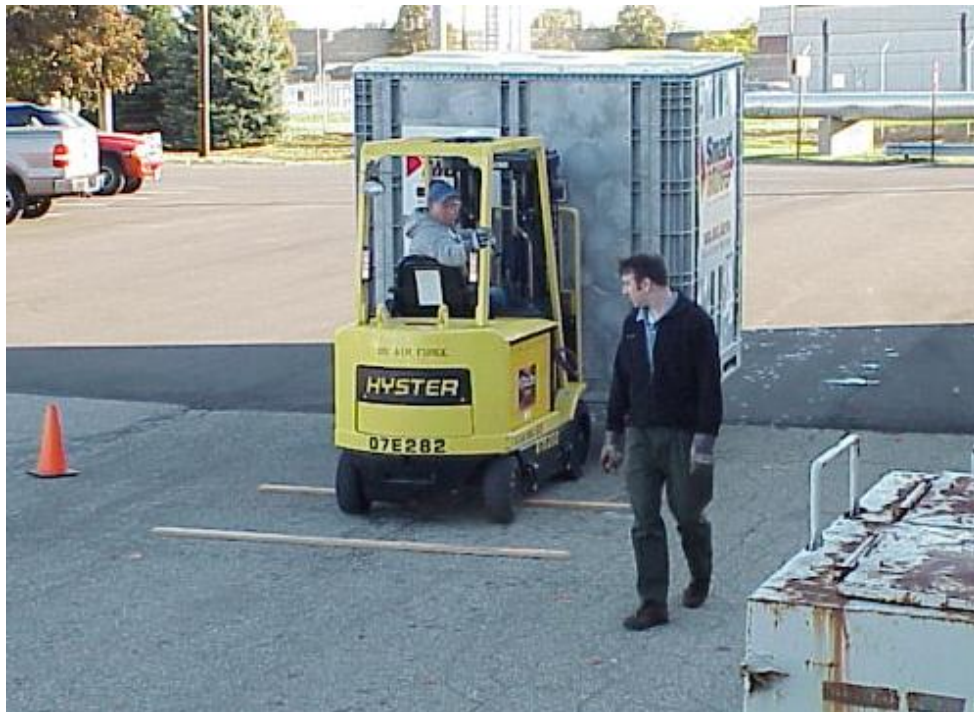
**Figure 24.** Forklift transport test, +125°F & 95% RH.

Procedure: The container was conditioned for 24 hours in an environmental chamber at the above temperature and humidity. At the end of this period, the container was removed from the chamber by the tine openings on the forward (door) side and Test Sequence 2 was repeated; the container was picked up on the left side for the second round trip over the test course (Appendix 2, Figure 24).

Results: There was no instability, weakening of, or damage to any component of the container. The container met test requirements.

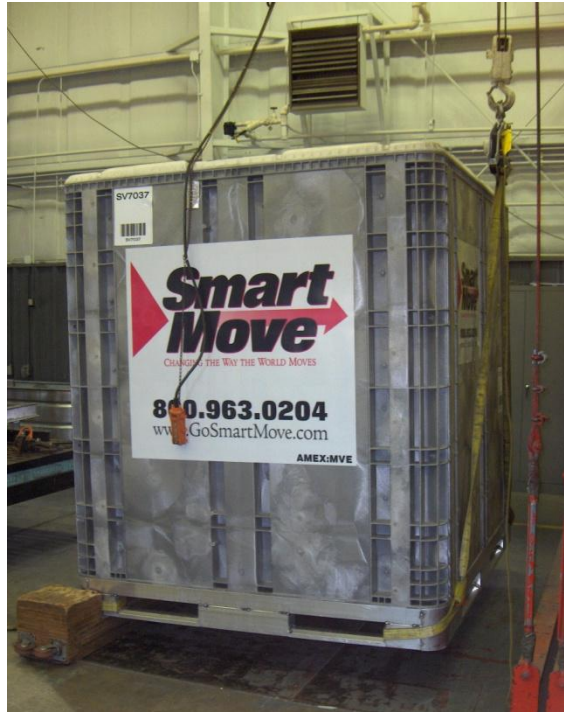
**Figure 25.** Rotational edgewise drop test, +125°F & 95% RH.

Procedure – The container was conditioned for 24 hours in an environmental chamber at the above temperature and humidity. At the end of this period, Test Sequence 3 was repeated (Appendix 2, Figure 25). The container was visually inspected for damage.

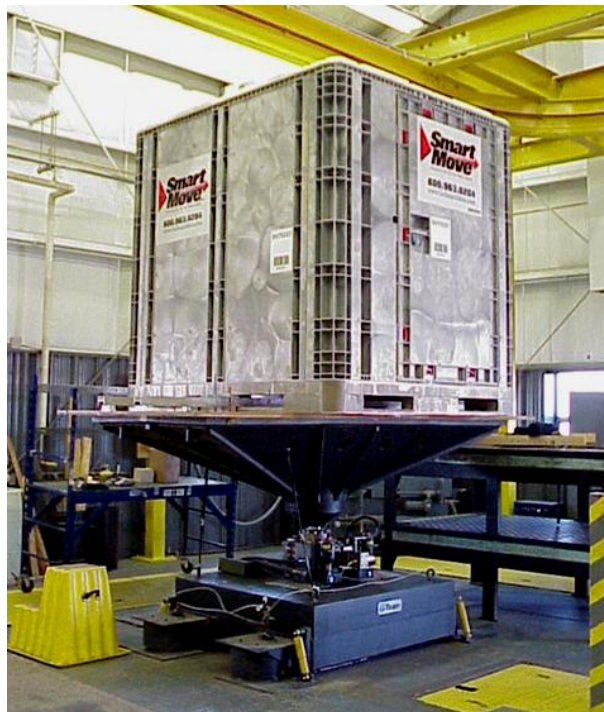
**Figure 26.** Vibration test, ambient.

Procedure – A sheet of 3/4-inch plywood was bolted to the top of the vibration table, and the container was placed on the plywood. Restraints were used to prevent the container from sliding off the table. The container was allowed approximately 1/2-inch unrestricted movement in the horizontal direction from the centered position on the table (Appendix 2, Figure 26).

The table frequency was increased from 3.5 Hz until the container left the table surface (approximately 3.65 Hz). At one-inch double amplitude, a 1/16-inch-thick flat metal feeler could be slid freely between the tabletop and the container under all points of the container. Repetitive shock testing was conducted for 2 hours at ambient temperature.

Results - The loaded container was vibrated at 3.65 Hz for 2 hours. At the end of testing there was no visible damage to the container and all components had remained in place. The container met the test requirements.

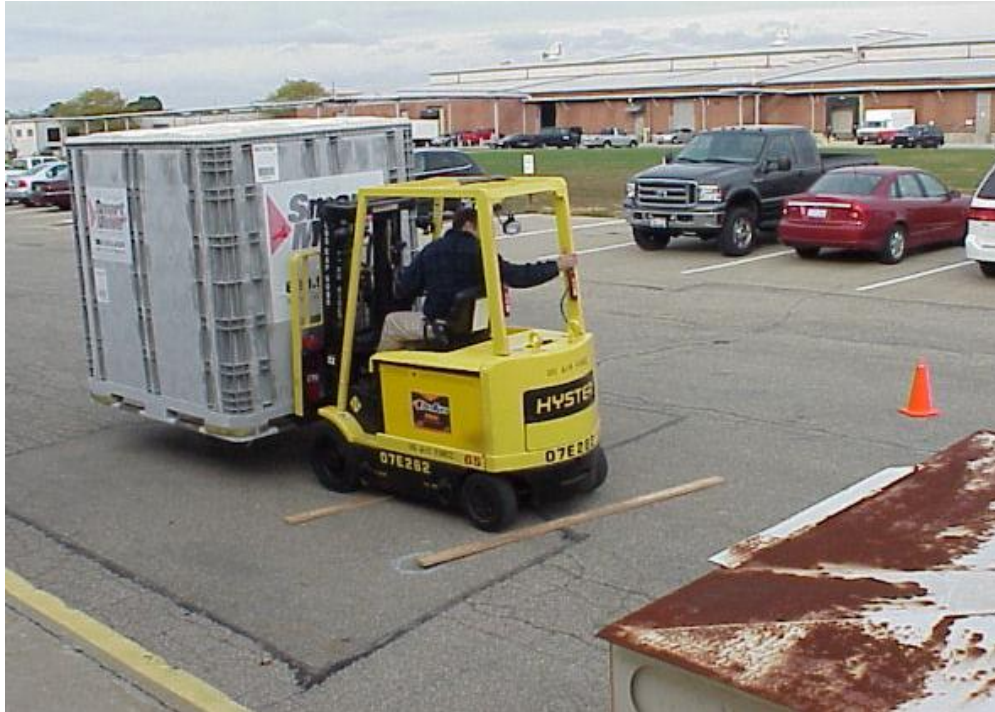
**Figure 27.** Forklift transport test, -30°F.

Procedure: The container was conditioned for 24 hours in an environmental chamber at the above temperature. At the end of this period, the container was removed from the chamber by the tie openings on the aft side and Test Sequence 2 was repeated; the container was picked up on the right side for the second round trip over the test course (Appendix 2, Figure 27).

Results: There was no instability, weakening of, or damage to any component of the container. The container met test requirements.

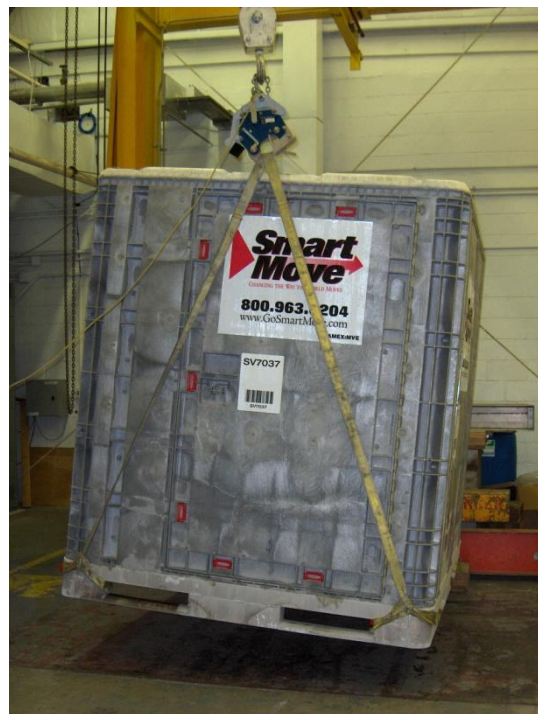
**Figure 28.** Rotational cornerwise drop test, -30°F.

Procedure – The container was conditioned for 24 hours in an environmental chamber at the above temperature. At the end of this period, Test Sequence 3 was repeated (Appendix 2, Figure 28). The container was visually inspected for damage.

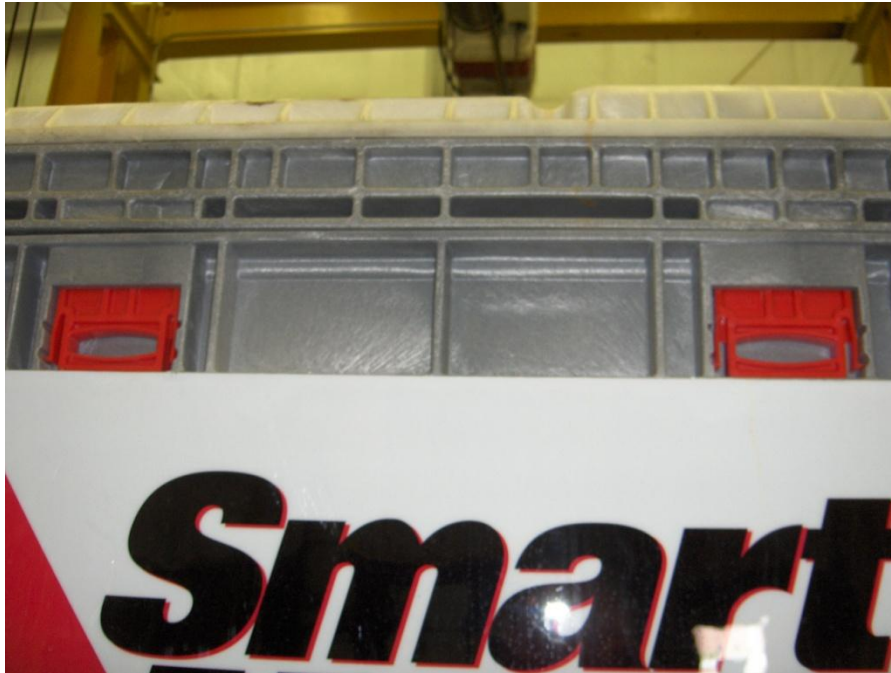
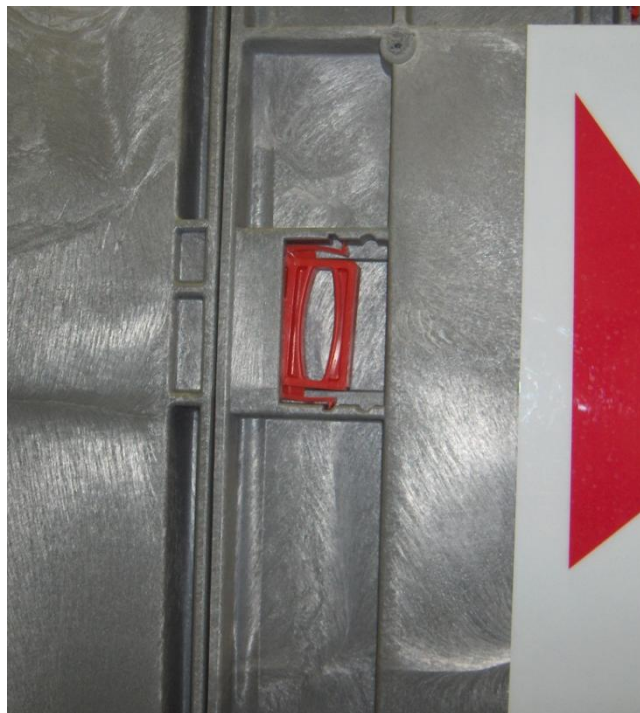
**Figure 31.** Slippage of latches 1 & 2 due to impacts from high temperature rotational drops.

**Figure 32.** Slippage of latch 3 due to impacts from high temperature rotational drops.

Results – Upon conclusion of testing, latch 3 had partially released, coming out of the first locking groove; latches 1 & 2 had completely released (Appendix 2, Figures 31 & 32). These latches began their releases throughout the drops, and were not put back into place during testing. The latches otherwise remained in place, and the edges and corners of the door remained closed. There was no other movement or shifting of container components, and no instability, weakening of, or damage to any component of the container. Other than the described movement of the three latches, the container met test requirements.

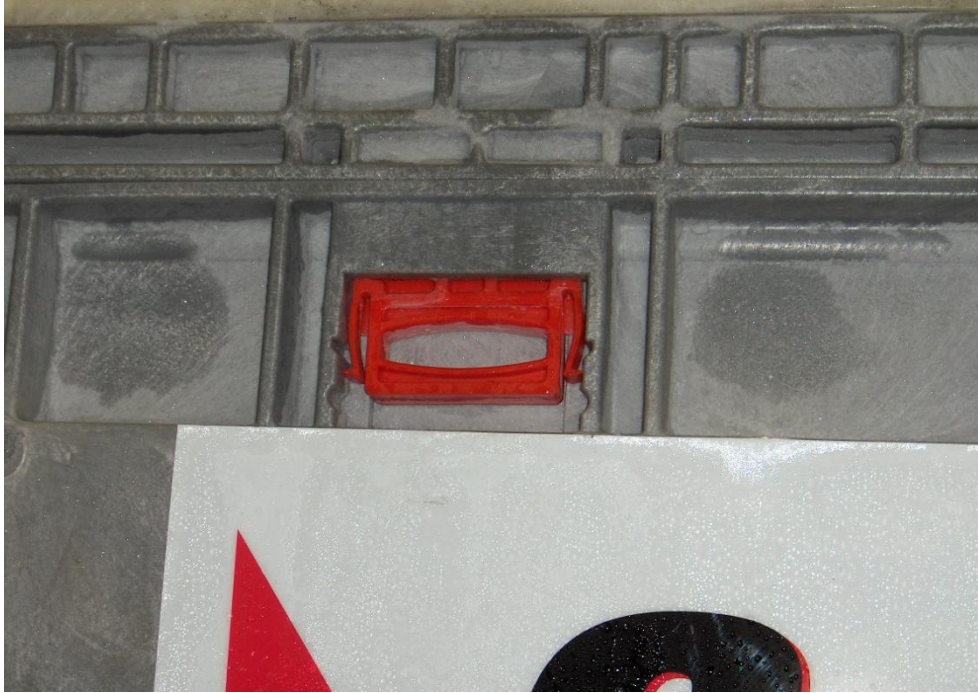
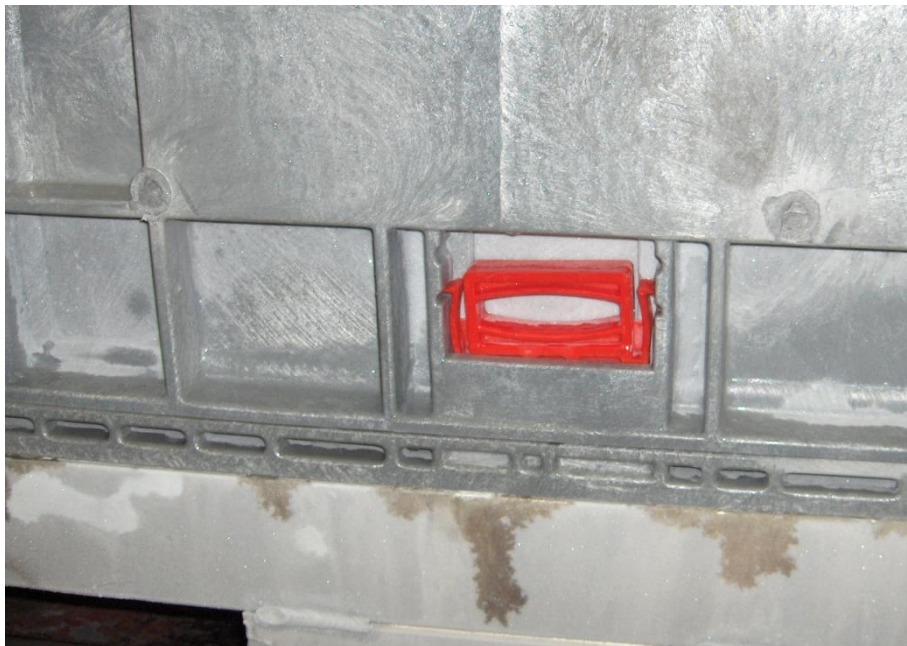
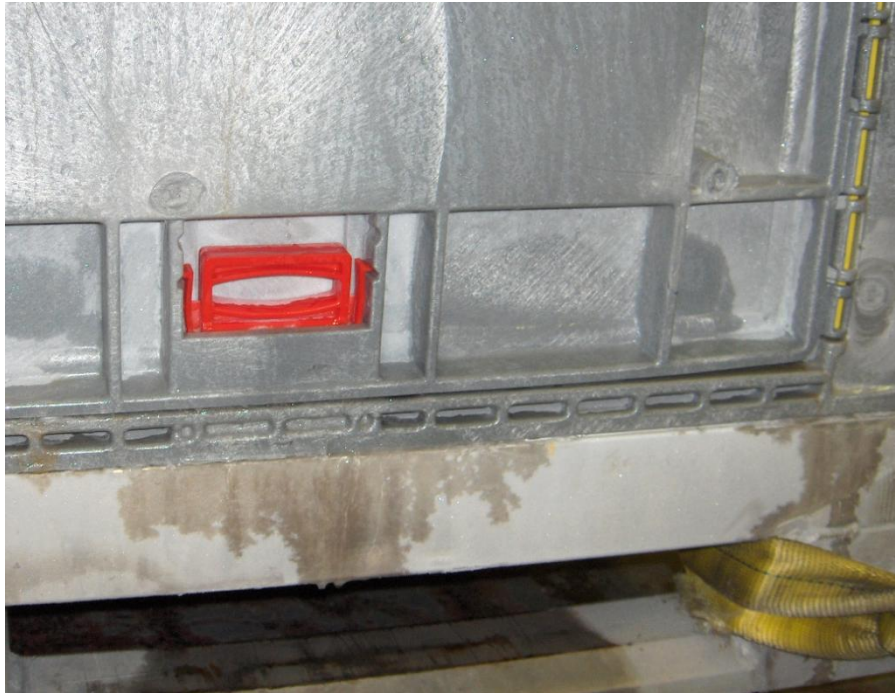
**Figure 33.** Slippage of latch 2 due to impacts from low temperature rotational drops.

**Figure 34.** Slippage of latch 6 due to impacts from low temperature rotational drops.

**Figure 35.** Slippage of latch 7 due to impacts from low temperature rotational drops.

Results – Upon conclusion of testing, latches 1, 6 & 7 had partially released, coming out of the first locking groove; latch 2 had completely released (Appendix 2, Figures 33 - 35). These latches began their releases throughout the drops, and were not put back into place during testing. The latches otherwise remained in place, and the edges and corners of the door remained closed. There was no other movement or shifting of container components, and no instability, weakening of, or damage to any component of the container. Other than the described movement of the three latches, the container met test requirements.

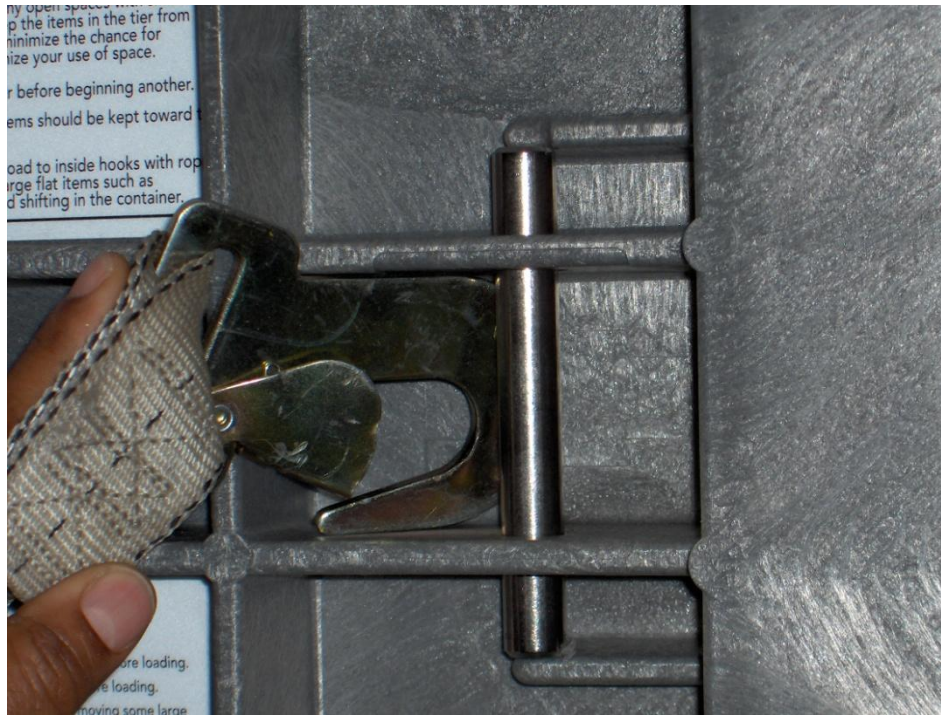
**Figure 36.** Internal tie-down point and standard tie-down strap hook.

**Figure 37.** Internal tie-down point and standard tie-down strap hook.
